AGENZIA NAZIONALE PER LA SICUREZZA DEL VOLO

FINAL REPORT

**SERIOUS INCIDENT
occurred to FOKKER 70, registration marks PH-KZH
Torino Caselle airport
16th of February 2002**

N. I/2/04

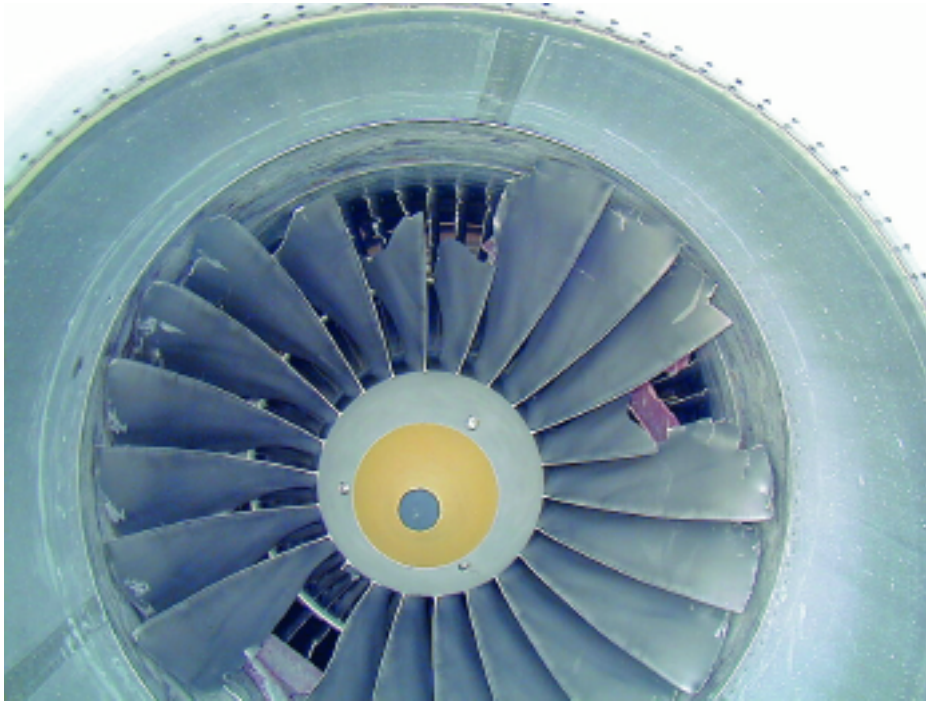
Photo 1

One fan blade was completely broken off near the root of the blade (see photograph 1 Appendix G). Three fan blades were broken off at approximately 50% of the fan blade length. One fan blade was broken at approximately 80% of the fan blade length, with 20% of the blade missing. Almost all leading edge tips of the remaining blades were damaged. There was also damage to the trailing edge of the fan blades. Some remains of the broken fan blades were found behind the fan. The accessory gearbox and the hydraulic pump housing were cracked. The PLA (Power Lever Angle) transducer was hanging on its wiring. The throttle linkage was detached from the fan case. The upper and lower cowling door opening rods were found loose with impact marks from the forward opening rod in the lower cowling door.

RH Engine.

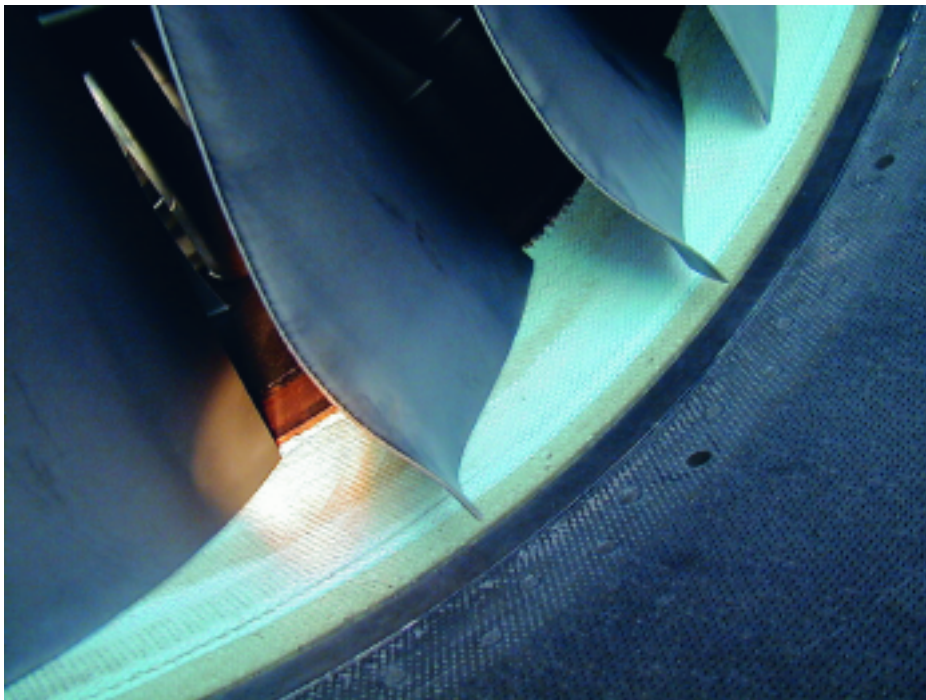
Photo 2

Five of the fan blade leading edge tips were bent forward. No damage was found on the remaining fan blades (see photograph 2 Appendix G). There was no evidence of bird ingestion.

LH Engine.

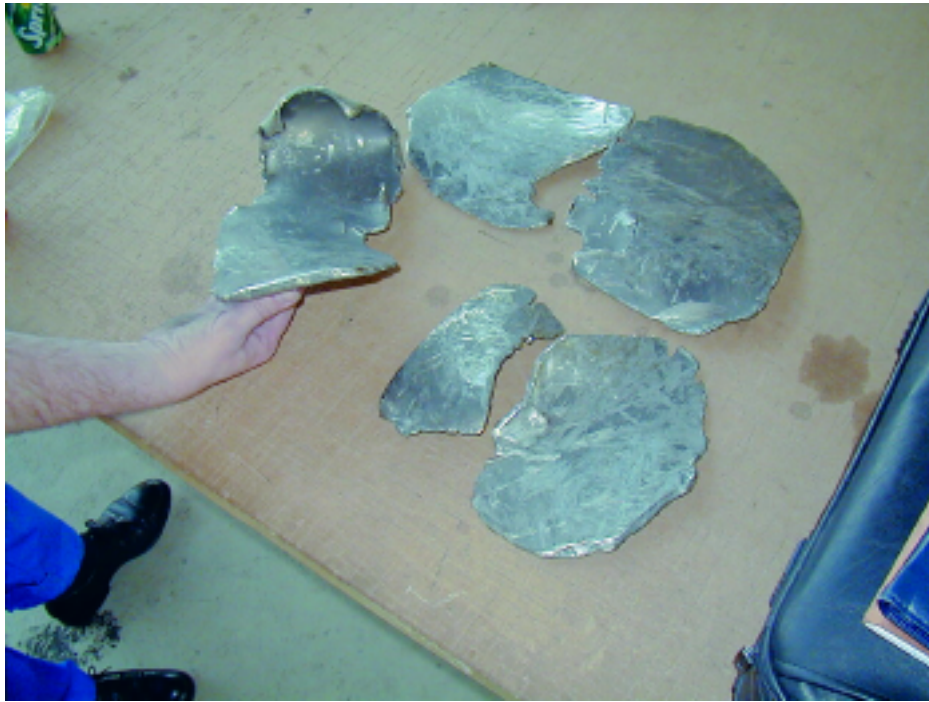
Photo 3

Prior to the daily airfield operation the runway was inspected at 05.25. Braking action tests were performed on the wet runway. The braking action was reported to be good and no irregularities on the runway were found. KL 1636 was the 8th aircraft to take-off after the runway inspection. Immediately after the return of KL 1636 the runway was closed and inspected for debris and/or damage. During the inspection immediately after landing engine material was recovered on the runway between 950 and 1.000 meters from the runway 36 threshold on the right side of the centreline between intersections D and C. The position where most of the debris was found was coincident with the approximate rotation point of the aircraft. The debris consisted of some small metal pieces (see photograph 3 Appendix G) which were later identified as debris from the fan blades and engine acoustic lining.

Amongst the engine debris, some large pieces of ice and a lot of smaller pieces of ice were found. The pieces of ice were described as appearing like glass, clear and compact and of different areas but with similar thickness of about 1 cm. The largest pieces found were approximately 10 cm x 10 cm, of irregular shape and also 1 cm thick.

RH Engine debris.
